BTT Automatyka	REGULATED COOLING SYSTEM FOR DIESEL ENGINE .	cooling system ORIGO 19 XI 2026	Projekt: Andrej	Nr rysunku:	Nazwisko: / Modyfikacja: / Schemat: 1
			Data: 18.11.2026	Funkcja: / Lokalizacja:	Lb. sch: 6 / Sch. nast: 3

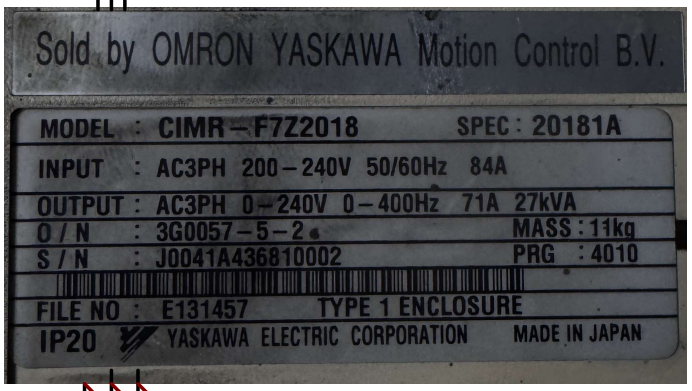
THE GRID ON THE VESSEL IS 3X220VAC

BAD AC MOTOR COOLING SYSTEM

3X220 VAC SHOULD BE 3X400 VAC

THIS MOTORREQUIRES 3X400VAC SUPPLY.

TWO WAYS TO REPAIR :

1 - NEW INVERTER 3x220VAC AND REPAIR OF THE PUMP BLOWER

2 - PURCHASE OF THE TRANSFORMER 220/400VAC AND NEW INVERTER
